Macaulay Point, Esquimalt: Archaeological Inventory

Prepared for:
Public Works and Government Services Canada
on behalf to the Department of Defence

March 31, 2003

Project #MR0329

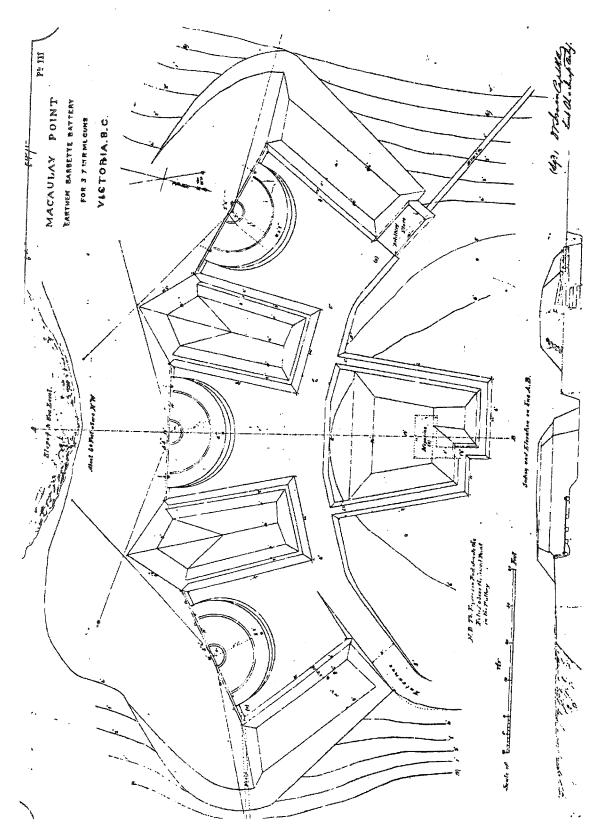
Figure 2. Macaulay Point embankments 1878 plan

(Plan III of a series by Lt. Col, Irwin. Public Record Office, Great Britain. On file with Ft. Rodd Hill and Fisgard Lighthouse National Historic Site.)

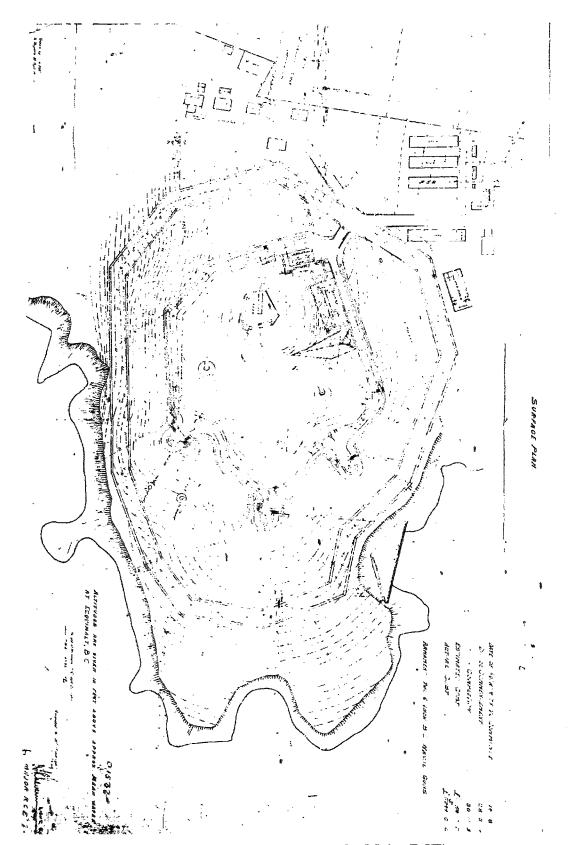
Figure 3. Macaulay Point battery ca 1895 (Plan by Major RCE).

(On file with Ft. Rodd Hill and Fisgard Lighthouse National Historic Site.)

In 1924, two of the 6" disappearing guns were removed from Macaulay Point and replaced with two 6" naval quick firing guns. The third disappearing gun remained in place until 1938 when the emplacements were modified; the 6" disappearing gun from the third emplacement was removed (Lovatt 1993) and the placement was used for storage (Municipality of Esquimalt 1998). The central emplacement is structurally different from those to the west and east, and comparison with the 1894/95 plan indicates that much of the original structure has been removed (Figure 4, Figure 3).

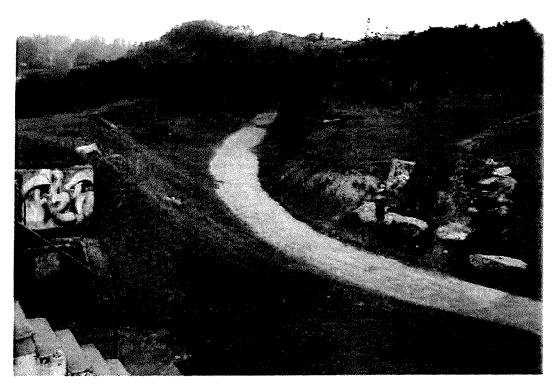
Plate 2. Inner trench of 1894/95 battery from westernmost gun emplacement

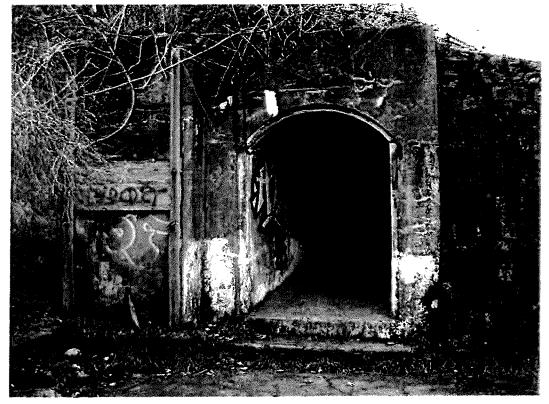
Plate 3. Tunnel from the keep with construction completion date 1895.

Many of the structures originally constructed in 1894/95 remain standing within the battery itself, including several buildings and the "murderhole" tunnel (Plate 3) leading out of the keep, although they have been modified by later upgrades (Figure 6). Both machine gun emplacements were relocated. Although Steveson and Kellogg (1974) indicate that the extant gun emplacements (Buildings 1198, 1328 and 1329) date to 1895, they have been modified to such a degree it is unclear if any of the original structures remain. The guardhouse shown on the 1894/95 plan (Figure 3) has subsequently been demolished but the foundation is clearly visible outside the tunnel. The keep of the 1894/95 battery has been largely removed although the depression and earth embankments between the 1942 bunker and the 1895 tunnel are remnants of this feature (Mumford 2004 personal communication). Horizontal courses of cobbles also remain in the keep walls (Plate 8); the depression and the cobble wall were recorded as MP-H2. As noted in the Study Area section, the Macaulay Point Battery is recognised as a site of National Historic Significance.

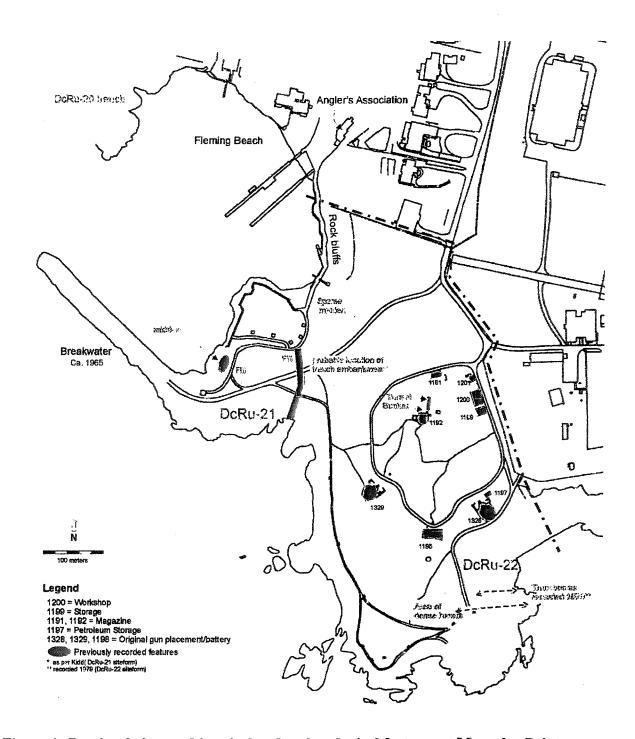
Figure 4. Previously known historical and archaeological features at Macaulay Point.

Three previously recorded archaeological sites are recorded on or in close proximity to Macaulay Point (Figure 4). DcRu-20 is located at Fleming Beach, west of the DND property; DcRu-21 and DcRu-22 are located on the DND property at Macaulay Point. DcRu-21 and DcRu-22 have recorded trench embankment features; DcRu-20 is comprised of both shell midden deposits and a trench embankment feature. The relationship between the sites is not understood; in fact the relationship between defensive sites, and between defensive sites and non-defensive sites is generally poorly defined. DcRu-20 is discussed below for the purposes of general context given the possible relationship between it and DcRu-21 and 22.

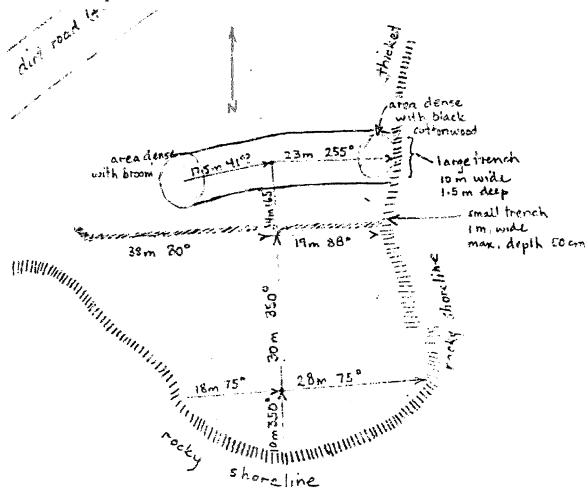
Figure 5. Trenches at DcRu-22 from 1979 siteform.

The crew mapped the location of two trenches on the point, one 1m wide by 0.5m deep, the other 10m wide by 1.5m deep (Figure 5). Both trenches run generally east to west across the point at DcRu-22.

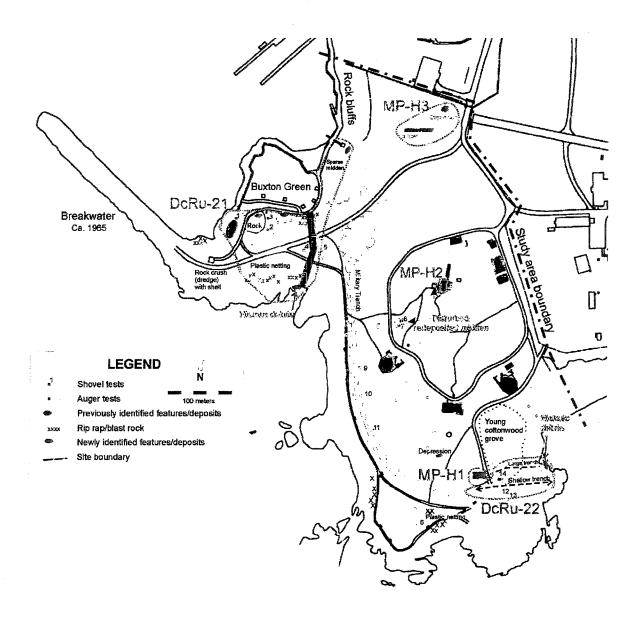
Figure 6. Archaeological Inventory Results with Test Locations

Dark shell-bearing soil was identified in two shovel tests (ST 7 & 8) and one exposure outside the boundary of DcRu-21, northeast of the westernmost gun placement (Figure 6). Shell and fire-cracked rock concentrations are high compared to the other deposits/exposures. The deposit is shallow (less than 10 cm deep) and over lays angular bedrock in an area not greater than 7 m wide (east-west) by 3 m (north-south). ST 8 was placed at the edge of the deposit (as determined by auger) and showed disturbance including cement and glass. Auger tests and examination of numerous exposures along the inner militarily trench and the surrounding informal trail system failed to locate additional cultural deposits. Shell was also noted in an exposure on the northern side of the central 1942 bunker. These deposits have been obviously disturbed and is not likely *in-situ*.

Numerous auger tests were conducted in the area of previously identified shell midden deposits (Figure 6). Three shovel tests (No. 1-3) and one auger test were positive for intact subsurface cultural deposits. The tests revealed midden capped by up to 30cm of mottled fills, blue and tan clay, inorganic light brown sandy silt, roots and rock crush. The midden is approximately 5-10cm thick and is characterised by loose dark brown loam with fragmented shell and fire altered rock in low concentrations. A yellow to orange glacial till/hardpan under lays the midden. The location of this deposit generally corresponds to the 30 x 17m area of midden recorded in 1979 (DcRu-21 siteform).

Other cultural exposures include intermittent lenses of midden along the original northern shore of the point proper (Figure 6). The northernmost of these exposures appears in the naturally formed "riser" of a step along an informal trail leading through a thicket downslope toward Buxton Green. The deposit is approximately 5 cm below the ground surface and measures 5 cm thick (Plate 16).

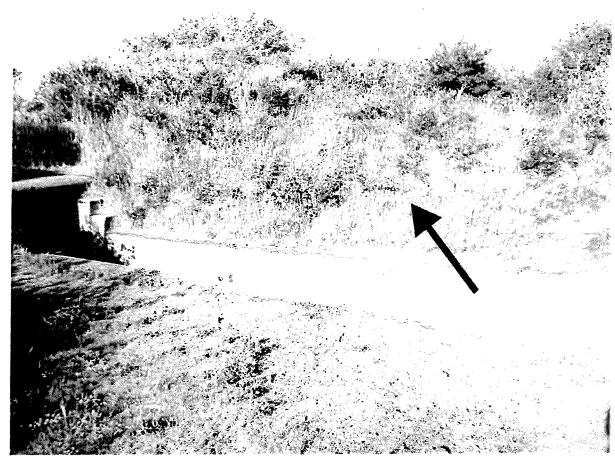
Plate 8. MP-H2, 1894/95 keep embankment s. At left, tunnel leads away from 1942 bunker; note horizontal courses of rock in background.

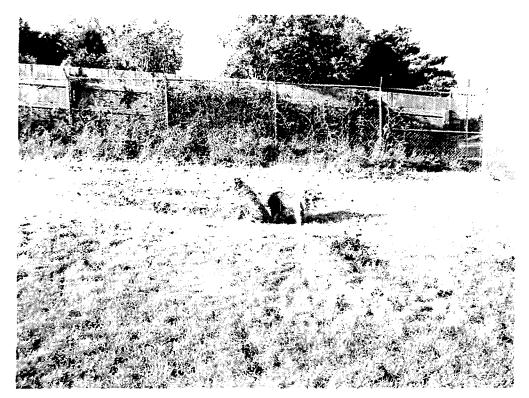
Plate 9. MP-H3, historical depressions.

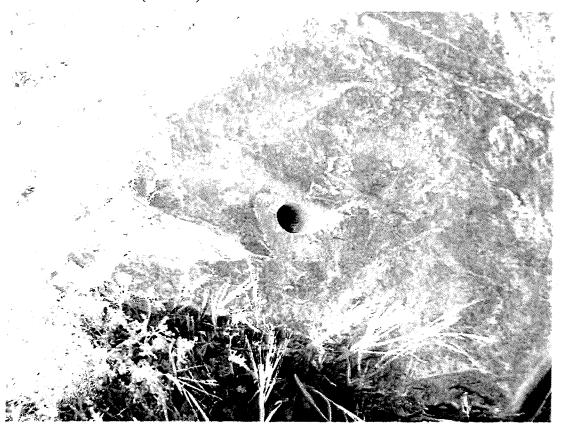
Plate 11. Blast rock with drill hole, near DcRu-22.

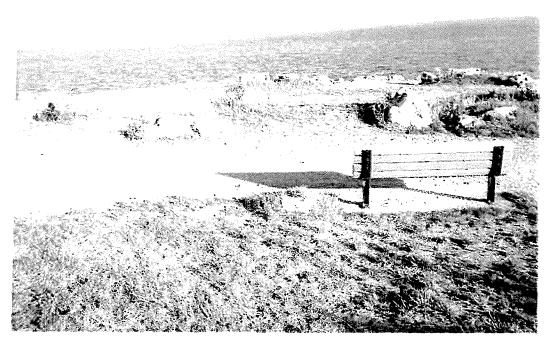
Plate 12. Hillocks and blast rock west of DcRu-22.

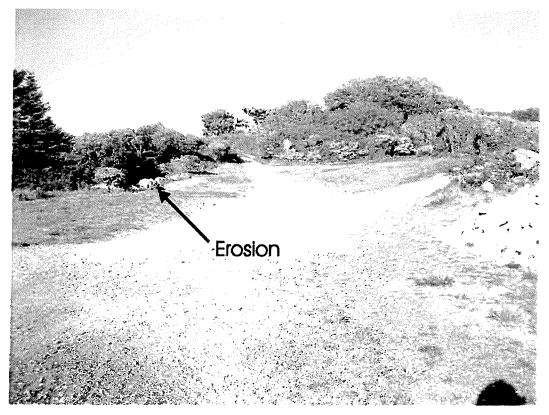
Plate 13. DcRu-21, area of reported trench from west.

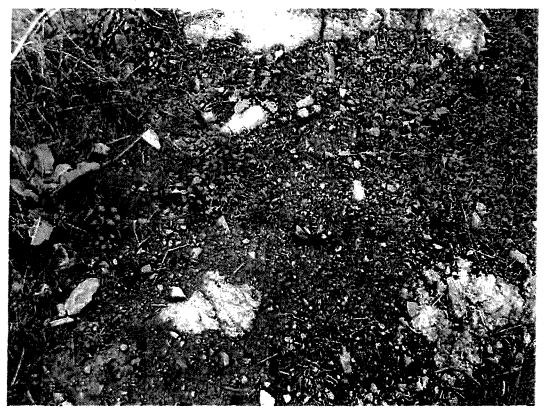
Midden was noted in scattered pockets over the eastern end of the breakwater and over rock outcrops at the base of the breakwater (Plate 15). These deposits are shallow and intermittent, but do not appear to the same as dredge materials that are also present (consisting of bleached crushed shell in grey blast rock crush and clay). This finding is consistent with the information recorded by Kidd in the original site description (Golder Associates 1998).

Plate 15. DcRu-21, example of surficial midden exposure near breakwater.

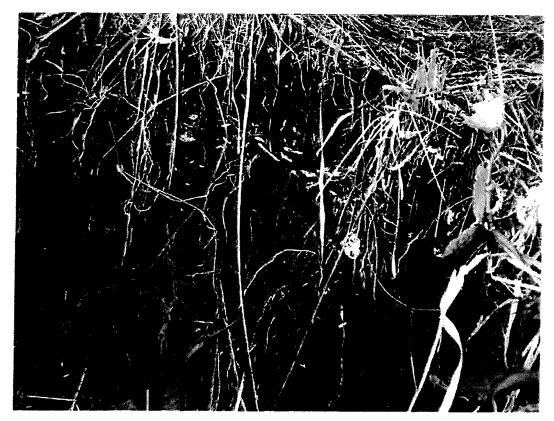
Plate 16. DcRu-21, shell midden in "riser" of step along trail to Buxton Green.
