FEDERAL HERITAGE BUILDINGS REVIEW OFFICE

BENCHMARKREPORT: 10-84

TITLE: Four Buildings
Albert Head
Canadian Forces Base Esquimalt, B.C.

SOURCE: Jennifer Cousineau, Cultural Sciences Branch

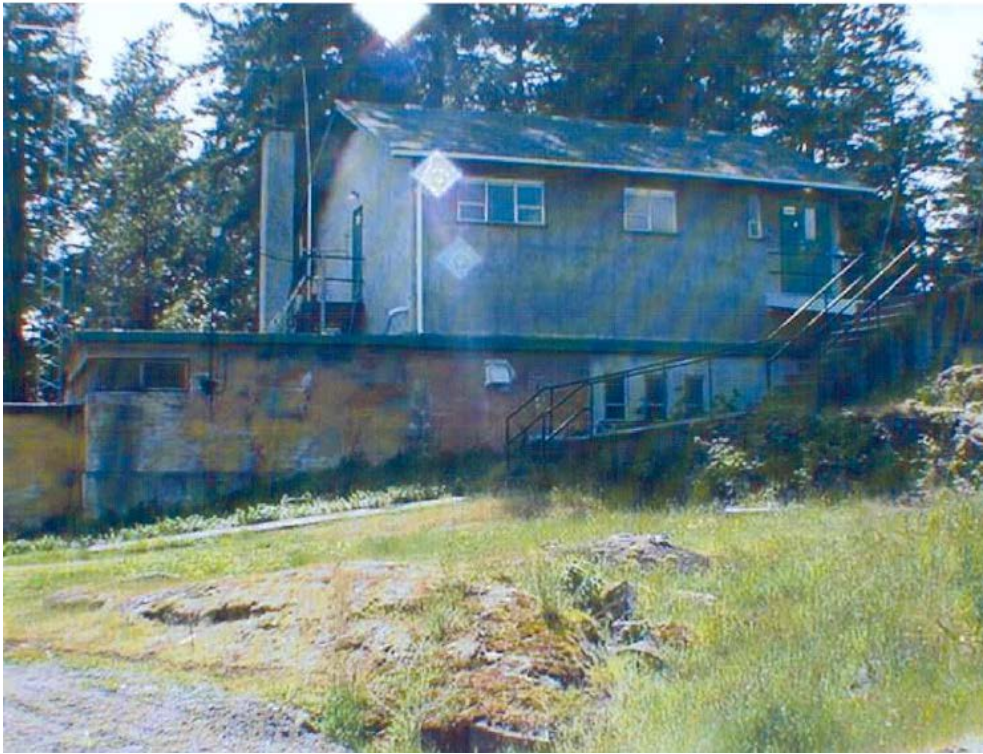
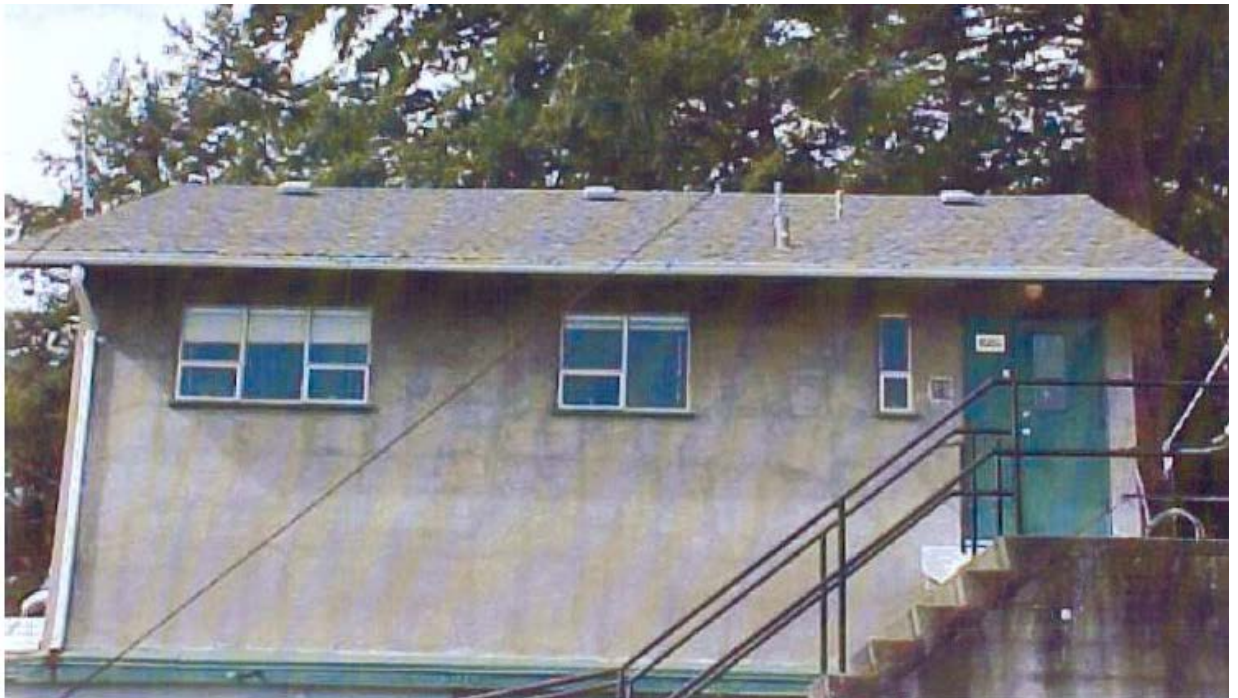
The Radio Monitoring Station is a modestly sized building of 3,534 square feet, consisting of two distinct parts (Figures 3-6). The lower section, consisting of a flat-roofed, concrete-and-stucco structure built into the side of a hill, was constructed in 1955. In 1974, a second, smaller, side-gable, grey stucco building was added over the northeast side of the first. Both parts of the building are extremely utilitarian and do not appear to express a particular architectural style. The flat roof of the first building is probably a result of the desire to conceal the building, which is on elevated ground, rather than a reference to what had by then become a hallmark element of modernist architecture. The two sections of the building are not particularly well integrated with each other from a visual perspective, although the earlier, flat roofed section has an interesting relationship to the landscape, into which, from some vantage points, it seems to disappear.

Figure 4. AH1003, Radio Monitoring Station, Albert Head, 1955 (DND, 2011).

Figure 5. AH1003, Radio Monitoring Station, Albert Head, 1955 (DND, 2011).

The materials employed in the Radio Monitoring Station appear to be fairly standard for utilitarian military construction in the period. The building has a concrete foundation. The lower section is wood frame with concrete walls, while the second floor structure is wood frame with concrete and stucco cladding. The roof is finished in asbestos shingles. A variety of utilitarian finishes can be found inside the building.

The Radio Monitoring Station is located on an isolated rocky site with mature trees screening it to the south, and areas of areas of grass, scrub, and exposed rock to the north (Figure 4). A paved road that becomes a smaller gravel pathway leads to the front entrance staircase, as well as to the opposite side of the building. Since the construction of the upper section in 1974, the main entrance to the building has changed from the ground level entrances to the upper level entrances. The ground level entrances are still used to access the storage spaces. The orientation of the original building is not entirely clear, but it appears to be a landward orientation, at odds with the current orientation of the upper section of the building, which is toward the Juan de Fuca Strait.

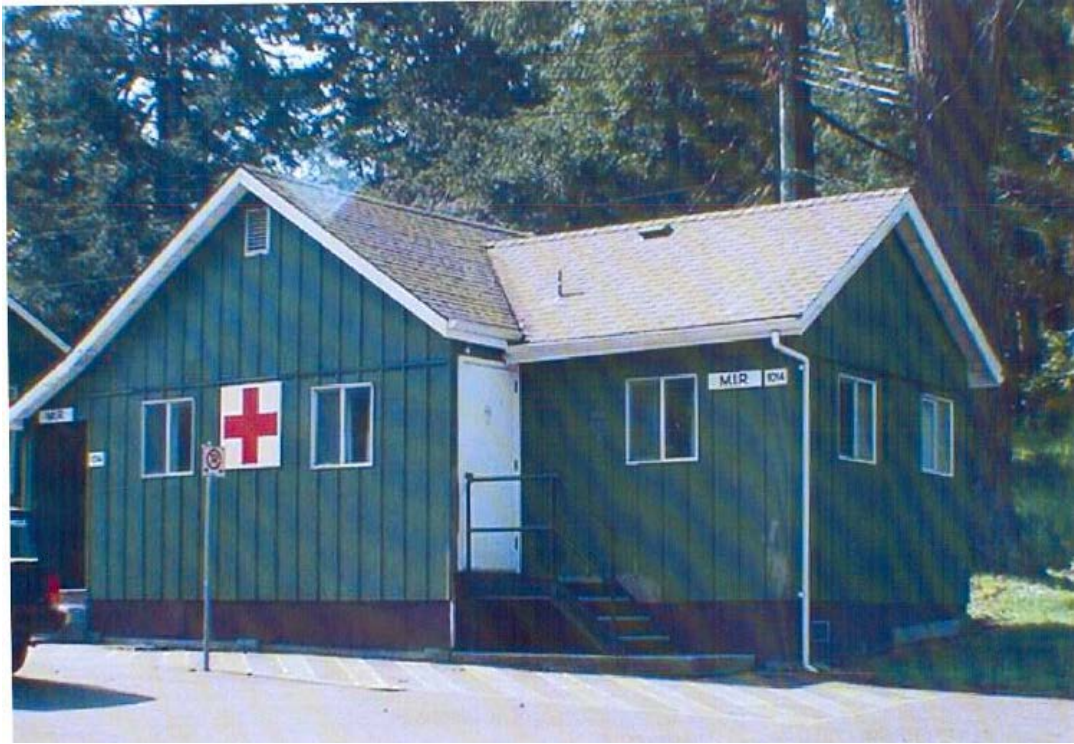
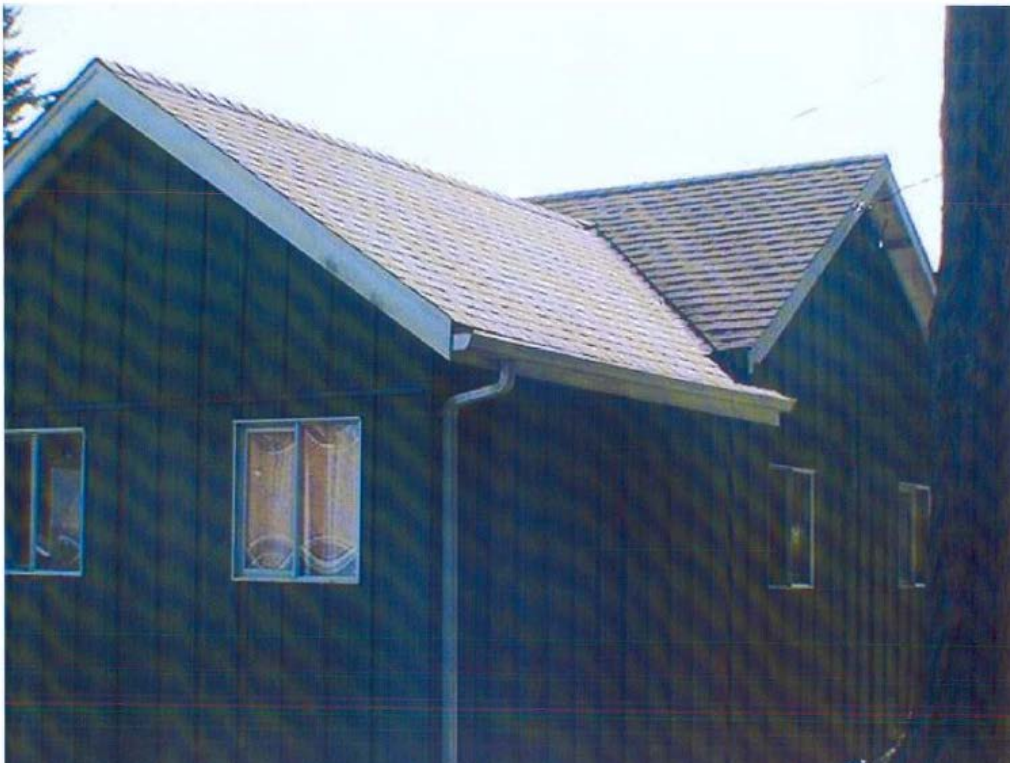
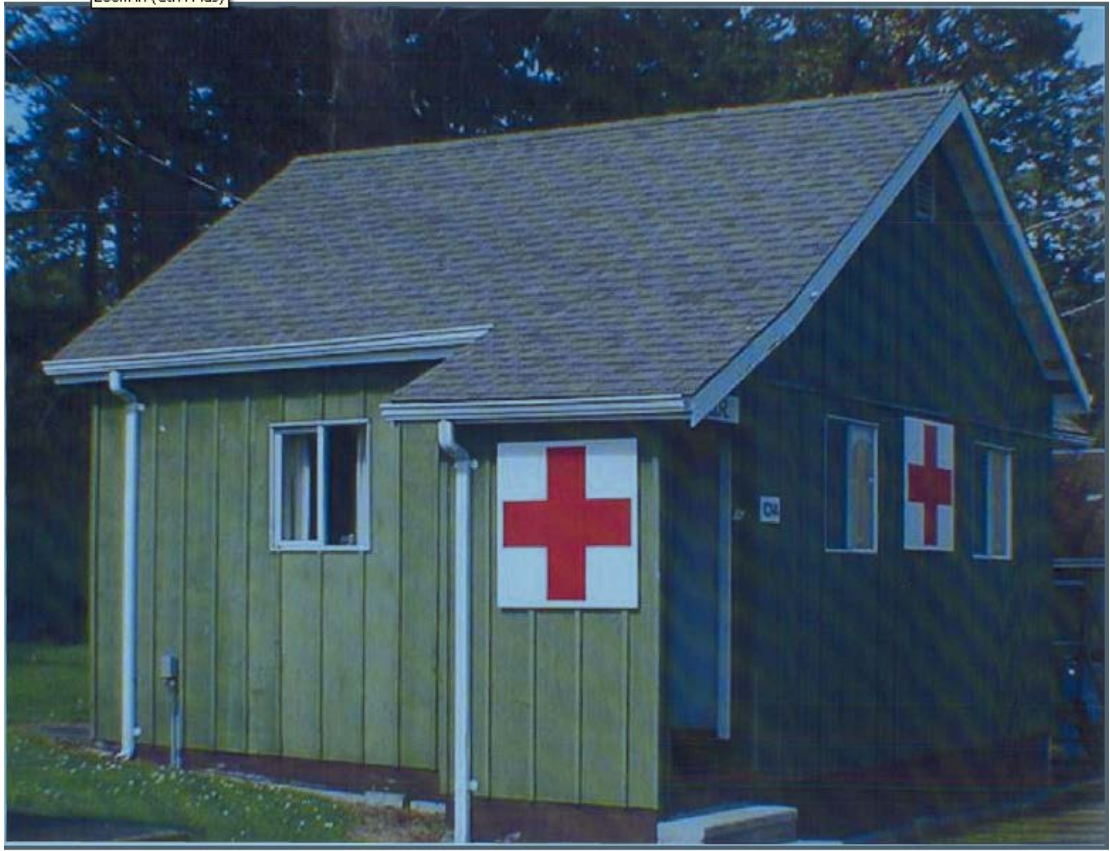
The Sick Bay is a small (467 square feet), one-storey building with two intersecting gable front roofs (Figures 7-10). The building's most striking feature is its distinctive green vertical board and batten cladding. It has a traditional, rather than modern appearance, due to its pitched roof and exterior cladding. The appearance of the building is consistent with military construction in the region during World War II. Similar wood-frame and wood-clad structures were built at Work Point in the 1940s. The building has 8 windows and is devoid of ornament. Its function as a medical clinic is signaled by large red and white cross signs on the front and sides of the building.

Figure 7. AH1014, Sick Bay, Albert Head, 1940 (DND, 2011).

Figure 8. AH1014, Rear and side elevation, Sick Bay, Albert Head, 1940 (DND, 2011).

Figure 9 AH1014, Sick Bay, Albert Head, 1940 (DND, 2011).

The Sick Bay is a wood-frame building clad in green, vertical board-and-batten pattern wood siding. It has an asphalt shingle roof. The materials are very standard for their period and location. They appear to have been well maintained and are in good condition, especially given the fact that the building was built as a temporary building more than sixty years ago.

The Sick Bay has two entrances on the front, street side of the building, the main entrance up three stairs under an extended section of the gable roof (Figure 7). Both entrances open directly onto a paved parking area on a secondary road. The building is otherwise surrounded by clipped lawns, with its rear elevation facing a screen of mature trees.

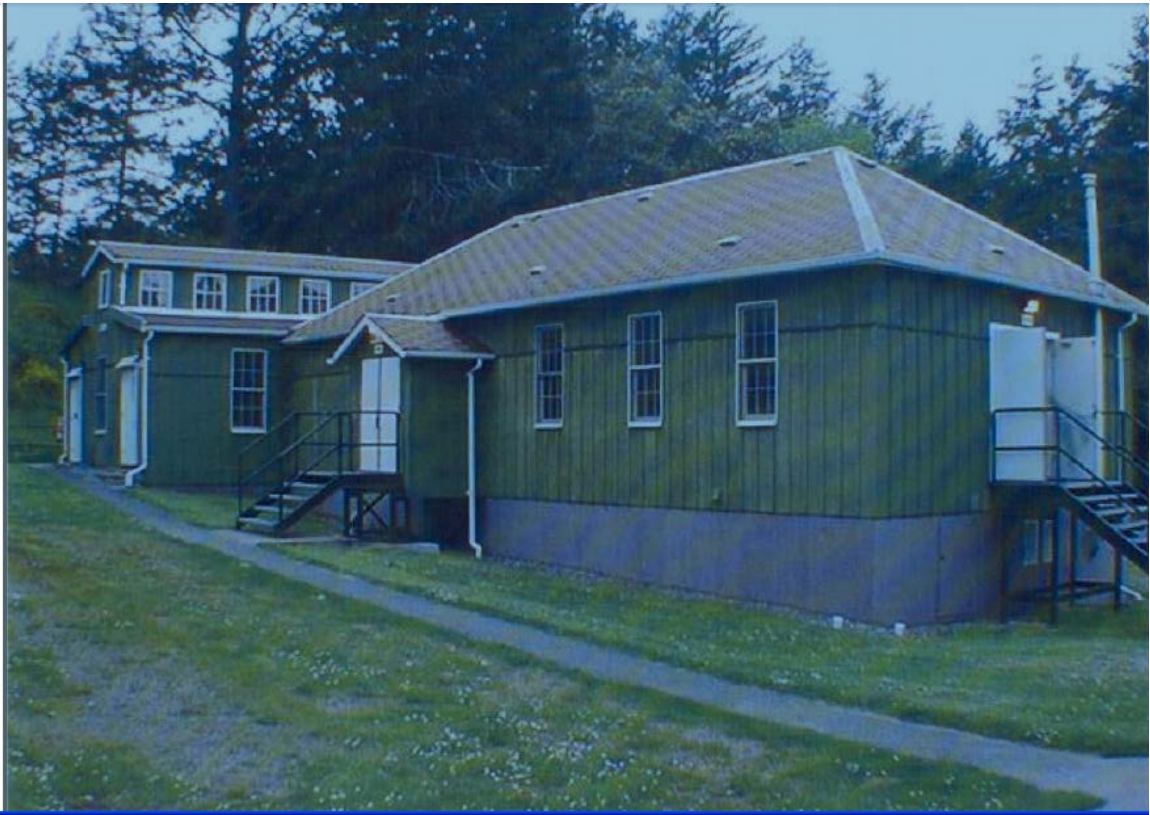
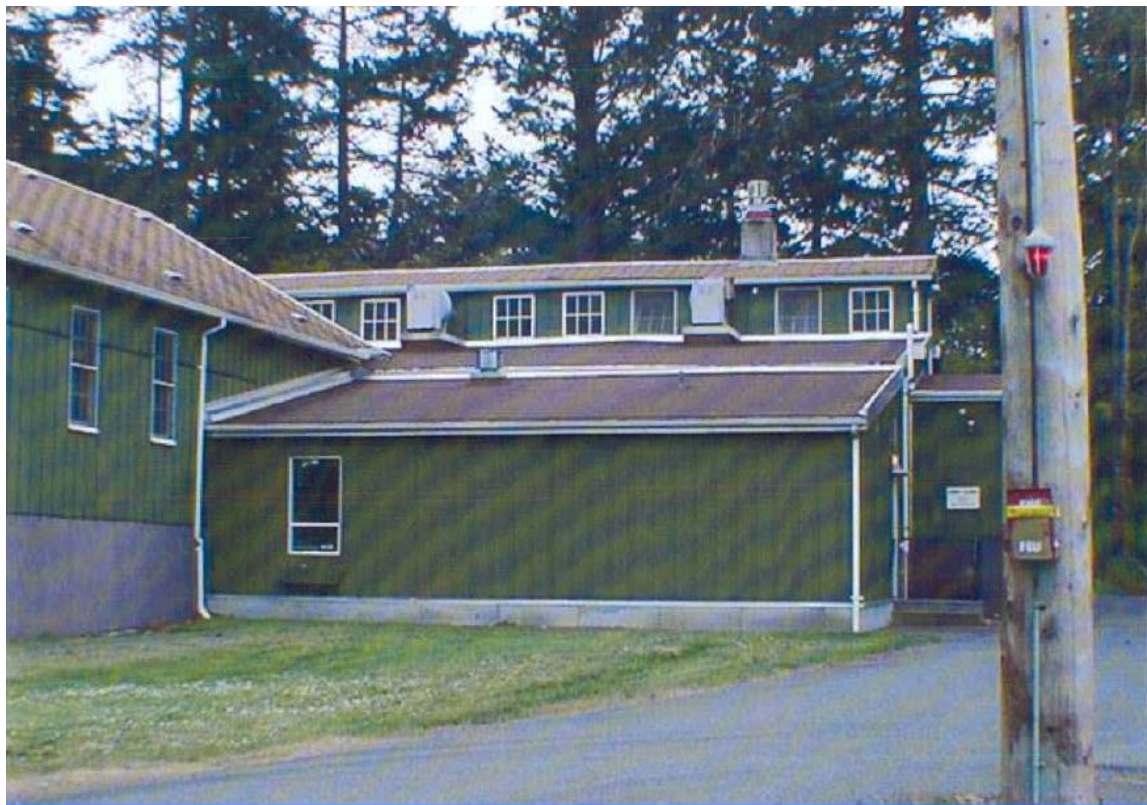
The Kitchen Mess is a large (3319 sq. ft), elongated L-shaped building (Figures 11-14). It has a concrete foundation and wood-frame and is clad in the distinctive green-painted vertical board-and-batten pattern wood siding that characterizes the temporary huts

constructed during the major expansion of phase of Albert Head during the Second World War. The building has no ornament but is distinguished by a prominent monitor roof (Figures 11, 12) over one section of the L. The other section (above the men's dining hall) has a hipped roof. The building has a pleasant, utilitarian, and fairly traditional appearance, due to its materials and roof types.

Figure 11. AH1015, Kitchen Mess, Albert Head, 1940 (DND, 2011).

Figure 12. AH1015, Rear elevation, Kitchen Mess, Albert Head, 1940 (DND, 2011).

Figure 13. AH1015, Kitchen Mess, 1940 (DND, 2011).

The Kitchen Mess is a wood-frame building clad in green, vertical board-and-batten pattern wood siding. It has an asphalt shingle roof. The materials are very standard for their period and location. They appear to have been well maintained and are in good condition, especially given the fact that they were built as temporary buildings more than sixty years ago.

The Kitchen Mess is surrounded by well-tended lawns (Figures 11-13). A paved walking pathway around three sides of the building provides access to the entrances to the Officers dining hall and the men's dining hall. The Officers' dining hall is accessed directly from the path, while the men's dining hall, on a slight incline, is elevated, and can be reached by climbing one of two metal staircases. The service entrances on the other side of the building have the benefit of a large paved parking lot. The fourth side of the building is screened by mature trees. If (as the different roof structures suggest) the men's dining hall is an addition, then the orientation as well as methods of egress will have changed significantly since the building was originally constructed.

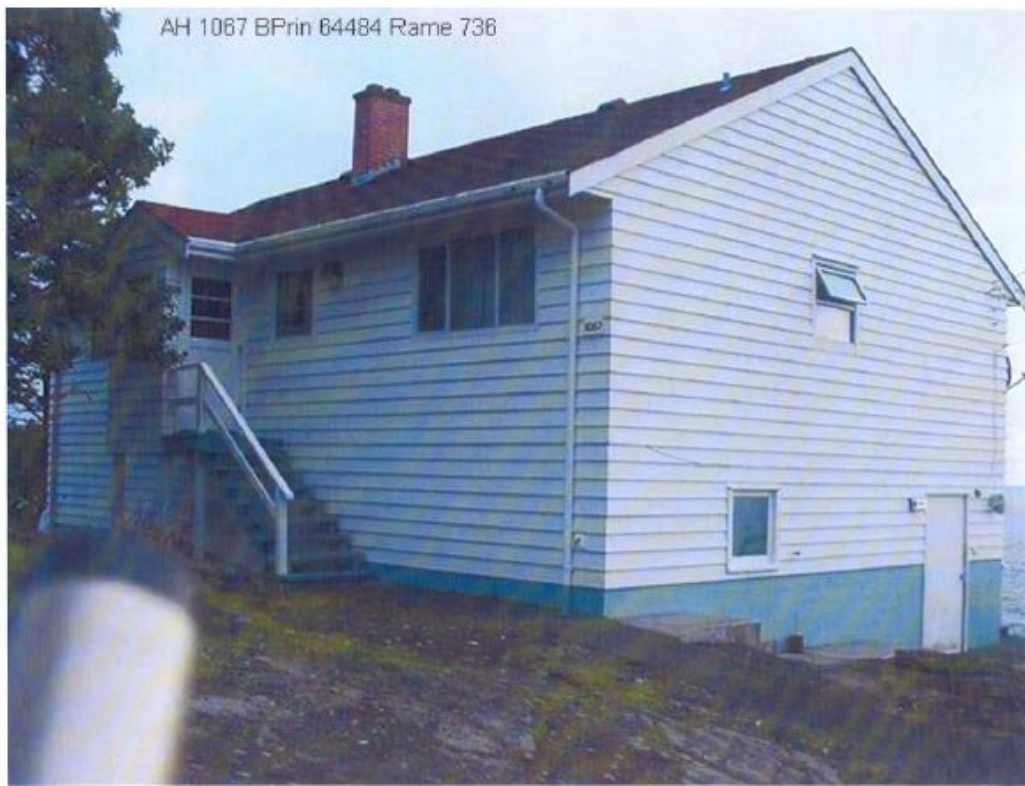
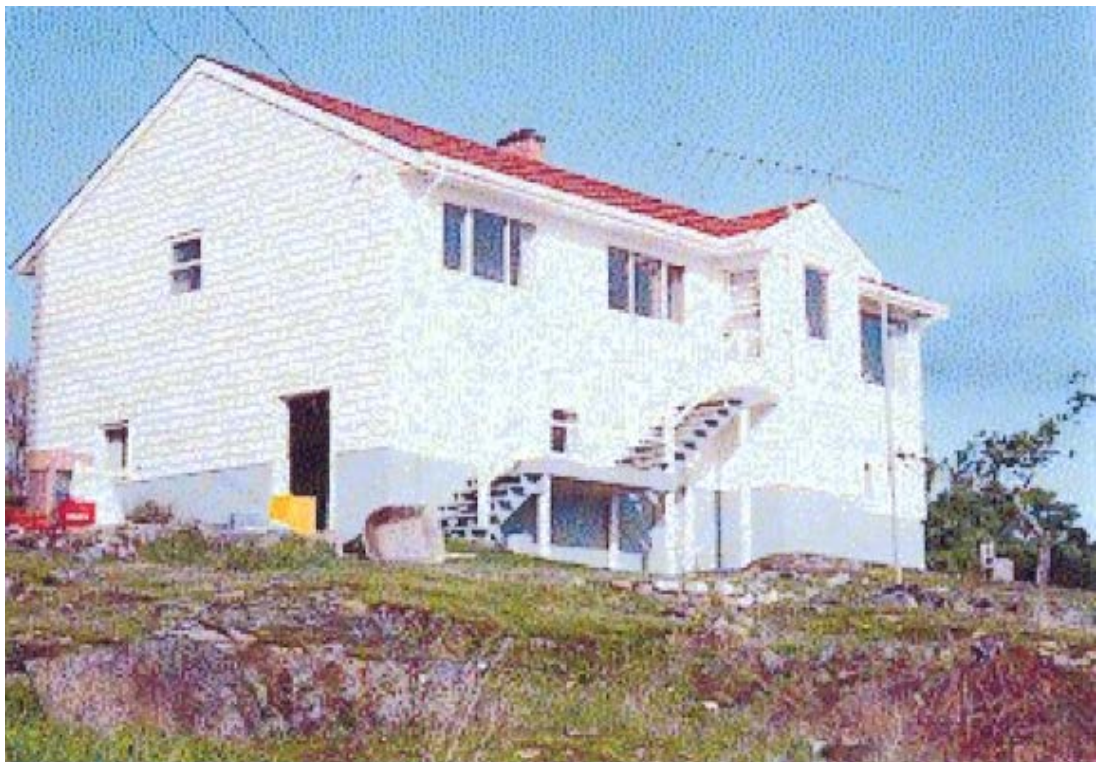
The Officers Mess is a modest, single-storey, side-gable house of 224.3 square metres (Figures 15-17). It has small projecting front and rear entrances topped by a gable, each accessed up exposed exterior staircases. Its bright red asphalt shingle roof presents a lively visual contrast with its simple white, horizontal wood siding. The design of the house is unselfconscious and straightforward, with no extraneous ornament and no detectable references to a particular historical style or local building tradition. This type of standardized house might have appeared anywhere in Canada in the 1960s.

Figure 15. Officers Mess, Albert Head, 1960 (DND, 2011).

Figure 16. Front elevation, Officers Mess, Albert Head, 1960 (DND, 2011).

Building AH1067 has an exposed concrete foundation, a wood frame and white-painted horizontal wood siding (Figure 16). Its roof is standard asphalt shingles with only their red colour to distinguish them from other roofs of the same material at Albert Head. Front and rear staircases are wood and of utilitarian construction. Windows are of three standard types, slider, awning, and fixed. Little care appears to have been given to establishing a consistent appearance as far as fenestration is concerned. The materials are functional and durable but neither the level of craftsmanship nor the materials themselves rise above the ordinary.

AH1067 sits on a sloping site that descends toward the Juan de Fuca Strait (Figure 16). The terrain around it is fairly open and rocky with some patchy grass and scrub and scattered groupings of trees and bush to the north and south. A pathway from the end of the main road leads to the rear entrance staircase, which, although it is not the main entrance from the perspective of the form of the house, may function as such because of the placement of the house facing the water, with its rear to the access road. No changes appear to have been made to this building as regards its relationship to its surroundings.

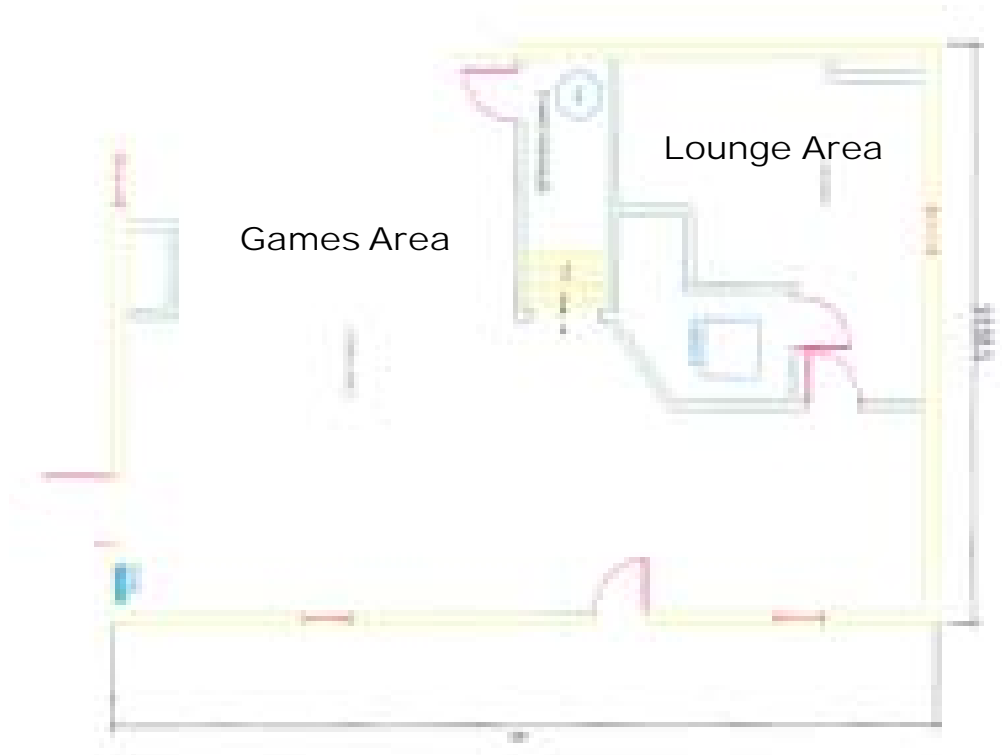
Figure 17. Plan, Officers Mess, Albert Head, 1960 (DND, 2011).

The plan of the Officers Mess is a simple rectangle with a mostly open interior (Figure 17). The main entrance on the east side of the building opens onto the large open space of what is now a multi-purpose games room. A small lounge is located in the northwest quadrant of the plan, and a stair-hall beside it leads to the basement. The main floor has windows on all sides providing the interior with natural light; the front windows also offer a pleasant view of the Juan de Fuca Strait. The building appears to be in reasonable condition and is currently occupied.
