FEDERAL HERITAGE BUILDINGS REVIEW OFFICE

BUILDING REPORT 89-69

TITLE: Officers' Mess (Former Officers'
Quarters, Building No. 1027)
Work Point Barracks
Canadian Forces Base Esquimalt
British Columbia

SOURCE: Ian Doull, Architectural History Branch

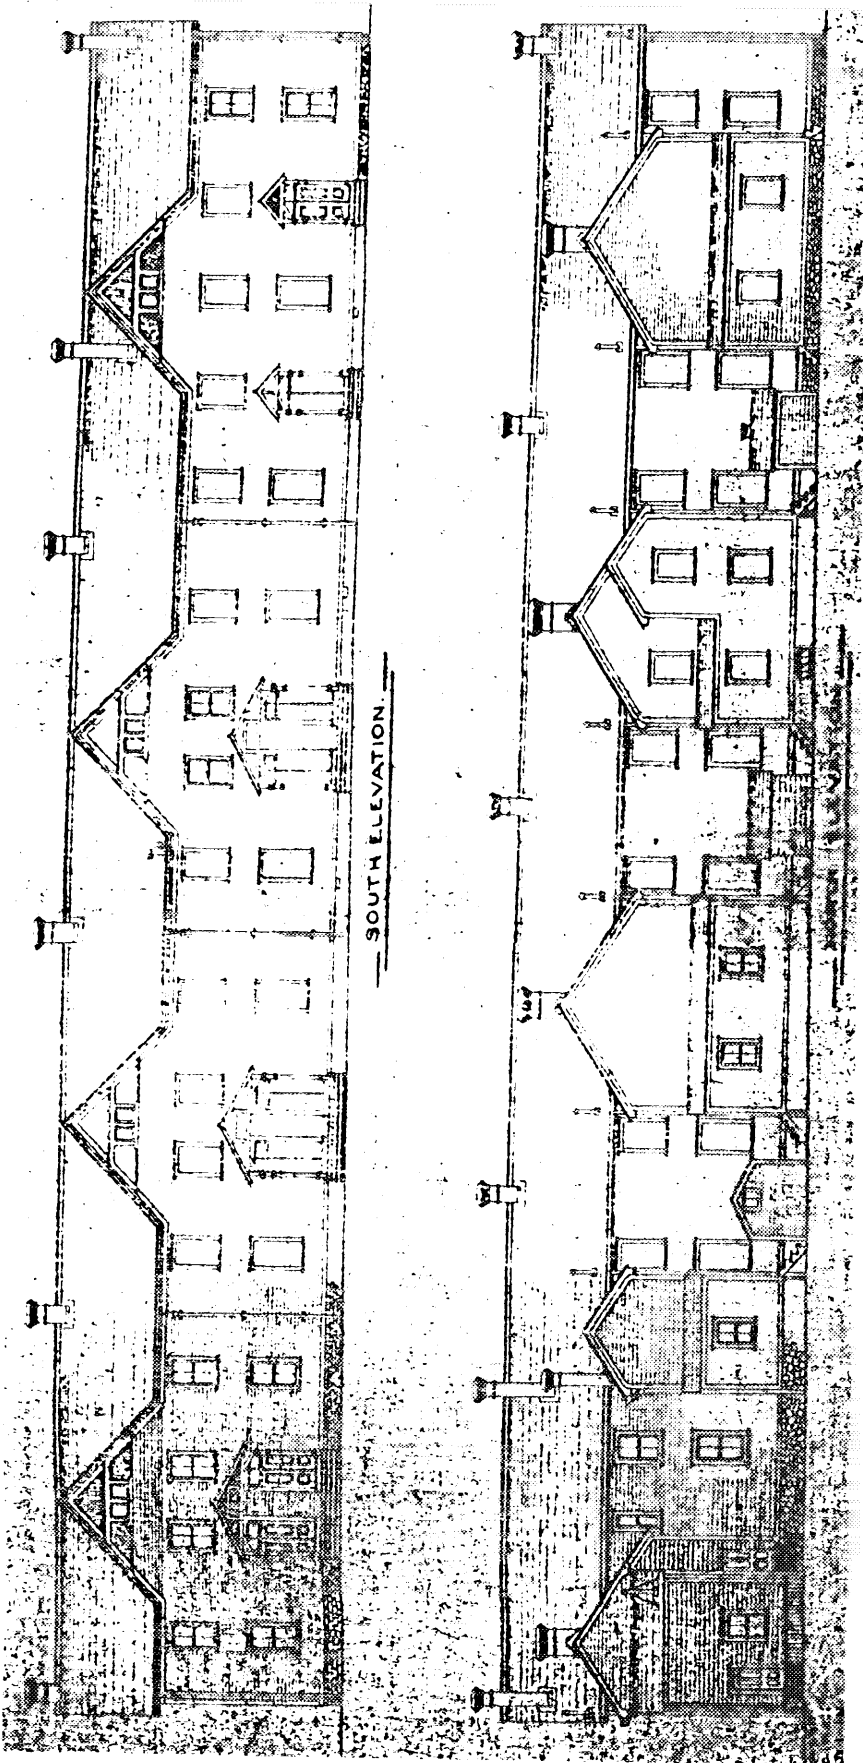
4 Officers' mess, Work Point Barracks, CFB Esquimalt: front and rear elevations, 1904. (Courtesy CFB Esquimalt Drafting Office.)

The officers' mess is a rectangular, two-and-one-half-storey frame structure, measuring 210 feet long and 36 feet wide, exclusive of the rear annexes.¹⁷ The elongated plan imparts a horizontal emphasis to the building, relieved on the main elevation by the four roof gables and open gabled porches which together formed the main features of the original design (subsequently modified, compare Figures 4 and 5). The positioning of doors, porches, and gables created a four-part façade, unified by a regular pattern of fenestration. The result

was a well-proportioned design, the symmetry of which was interrupted only slightly at the eastern end by the repositioning of doors and porches. The general design and plan of the building follow the tradition of domestic terrace or row housing. The locations of the doors give clear indication of the interior organization into individual residences; this is reinforced at the rear of the building by the kitchen and service annexes.

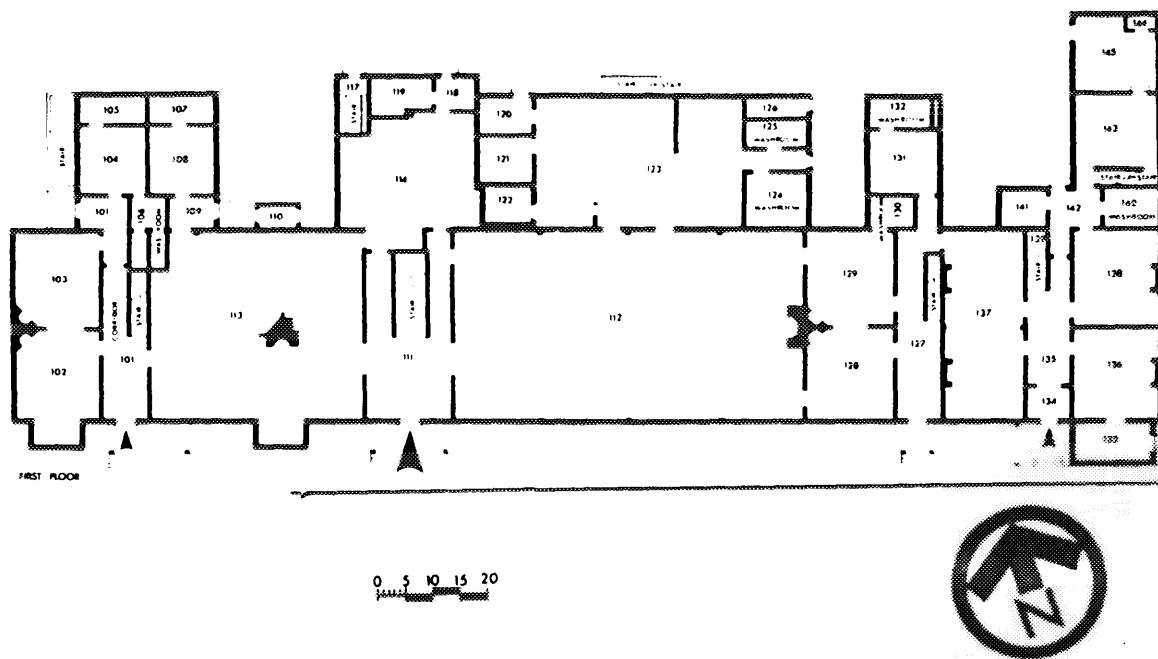
7 Officers' mess, first floor plan, 1974. (Stevenson and Kellogg, et al, "Building Survey Report Series on Dockyard, Signal Hill, Naden, Work Point, Munro Head, in CFB Esquimalt," photocopy courtesy DND.)

Substantial changes have been made to the interior to adapt the building to its more recent use. Only the two end units retain the general elements of their original plan, although both now have access to the central areas of the building. Much of the ground-storey central area has been converted to a dining hall

with associated service rooms and anterooms, achieved by the removal of several interior partitions (Figure 7). Several of the main entry doors which once served units in this area have been removed. The majority of second-storey bedrooms remain, but a central corridor extending the length of the building between the end units has been built between the front and rear rooms (Figure 18).

Most of the original interior detailing has been removed during alterations. Many of the fireplaces have been removed; of those remaining, only those in the dining room and anteroom (rooms 112, 113, Figure 7) remain functional, and they are early 1960s replacements of the original units. Those in rooms 128 and 129 appear to be original, although of unremarkable design, and feature carved mantelpieces and small grates, possibly intended to burn coal. Fireplaces and mantels also survive in the former commander's residence and in the single unit at the opposite end of the building. The former also retains its original second-storey stairway. Original wood mouldings of common design survive in a small number of rooms.²²

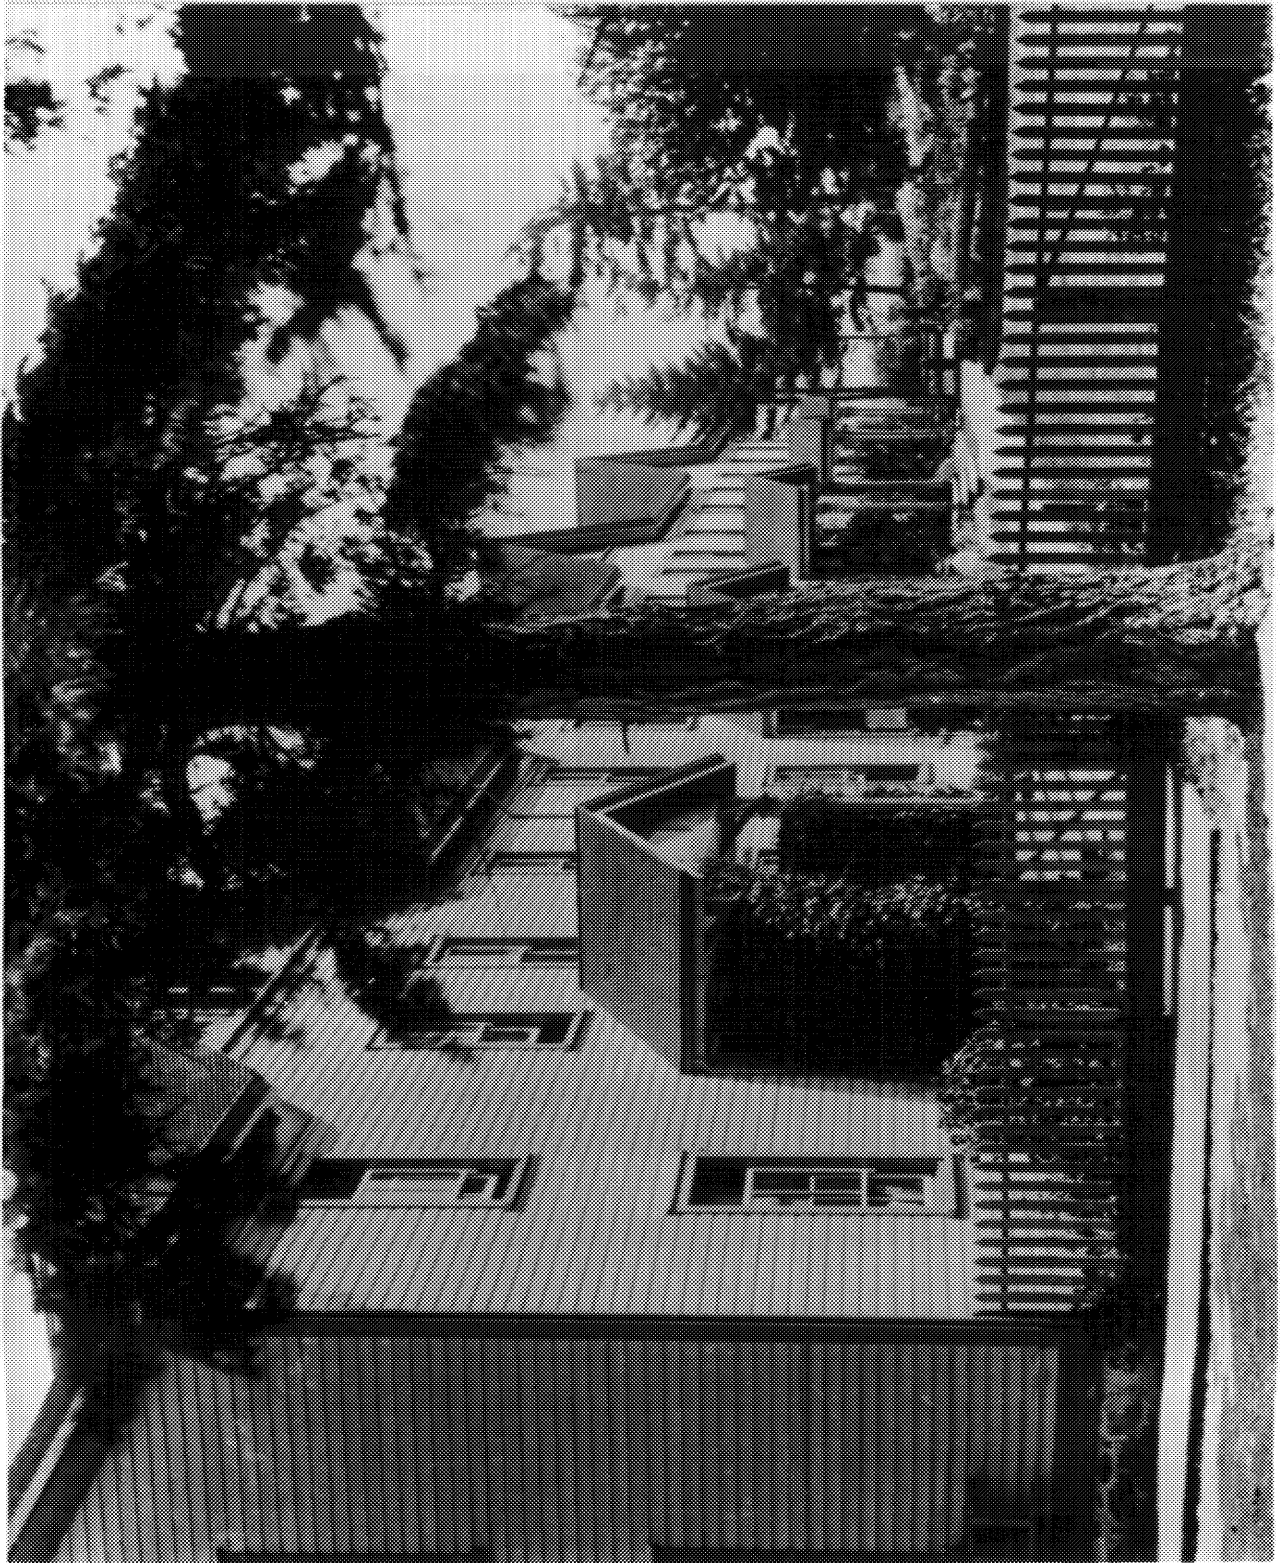
9 Officers' mess, perhaps ca.1900. (British Columbia Archives and Records Service, A-5699.)

picket fence which extended from the corner of the building southward towards the sea (Figure 9). Considerable care was taken to create a landscape combining new and existing plantings, lawns, and natural outcrops of rock. Site features consisted of a board sidewalk which extended along the main and side elevations, mature trees which predated the building's construction, and a formal lawn crossed by gravel pathways and containing gardens and shrubs. The same treatment exists today, with the exception that the fence and pathways have been removed and the sidewalk paved with concrete (Figures 20-22). A paved parking and vehicle circulation area extends along the rear and both sides of the building (Figures 22, 23). Four small outbuildings appear on the site, to the north (rear) and southeast (side) of the main structure. These are buildings no. 1021 and 1024 (Figure 24), a single and double garage to the rear of the mess; no. 1025, a small gardener's shed to the rear and east; and no. 1026, a small greenhouse erected since ca. 1948. The three older structures resemble the officers' mess in materials and construction (Figure 24). Although dated 1920-1942 by the Department of National Defence,²⁵ an 1895 Work Point site plan reveals buildings of similar size to those on the sites of nos. 1024 and 1025 (compare Figures 2, 3).

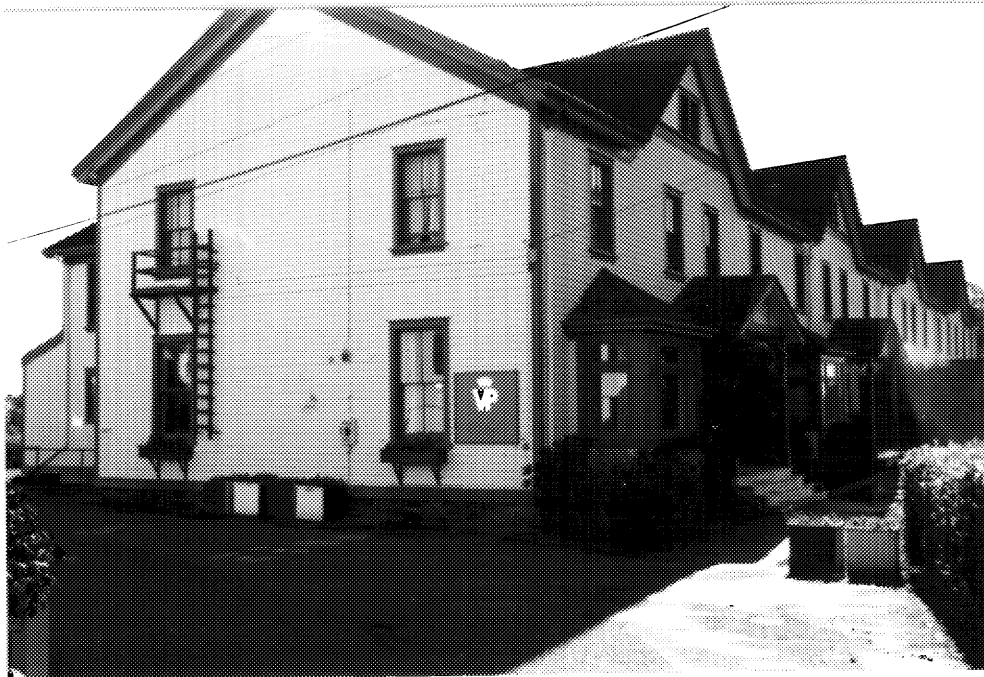
10 Officers' mess, side (west) and main (south) elevations. (Ian Doull, AHB, Parks, 1989.)

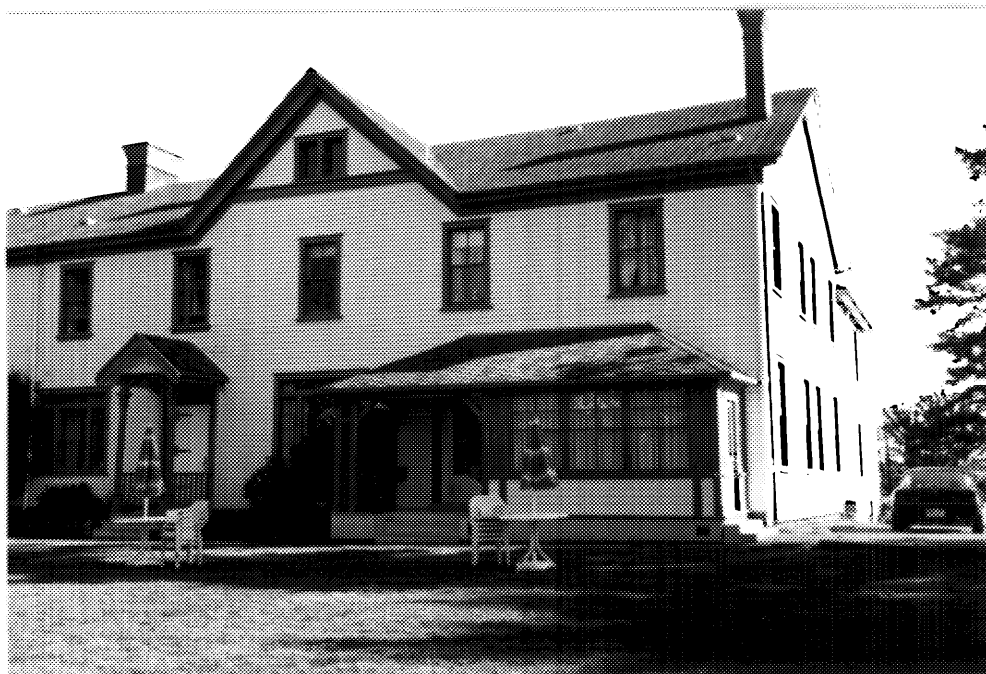
11 Officers' mess, main and side (east) elevations. (Ian Doull, AHB, Parks, 1989.)

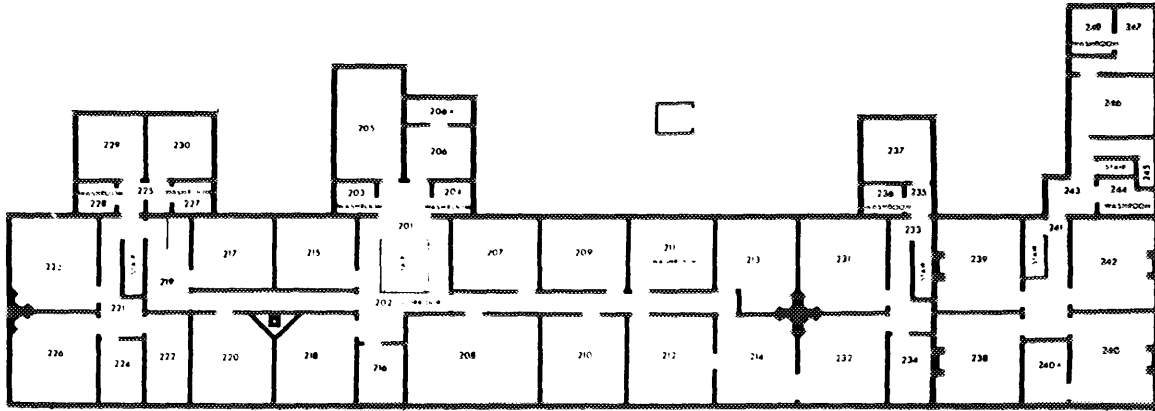
18 Officers' mess, second floor plan, 1974. ("Building Survey Report Series," photocopy courtesy DND.)

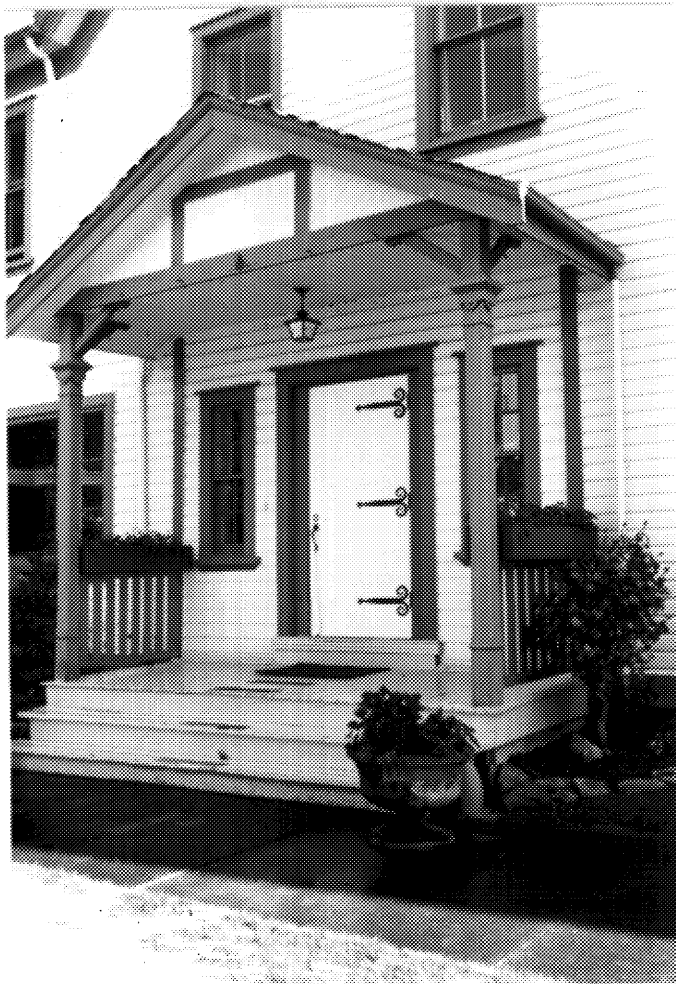
19 Officers' mess, main elevation, entrance porch detail. (Ian Doull, AHB, Parks, 1989.)

Although of relatively simple design, with modest decorative elements (Figure 19), the building exhibits competent craftsmanship reflected in a high degree of structural integrity. There is no exterior evidence of settling or of distortion of eaves, roof ridges or slopes, or walls. The deterioration of the foundation supports which has made necessary the upcoming repairs may be considered as a periodic maintenance problem, rather than a deficiency in craftsmanship, predictable for a frame building on an exposed site, standing only a few feet from the ocean which surrounds it on three sides (Figure 28).

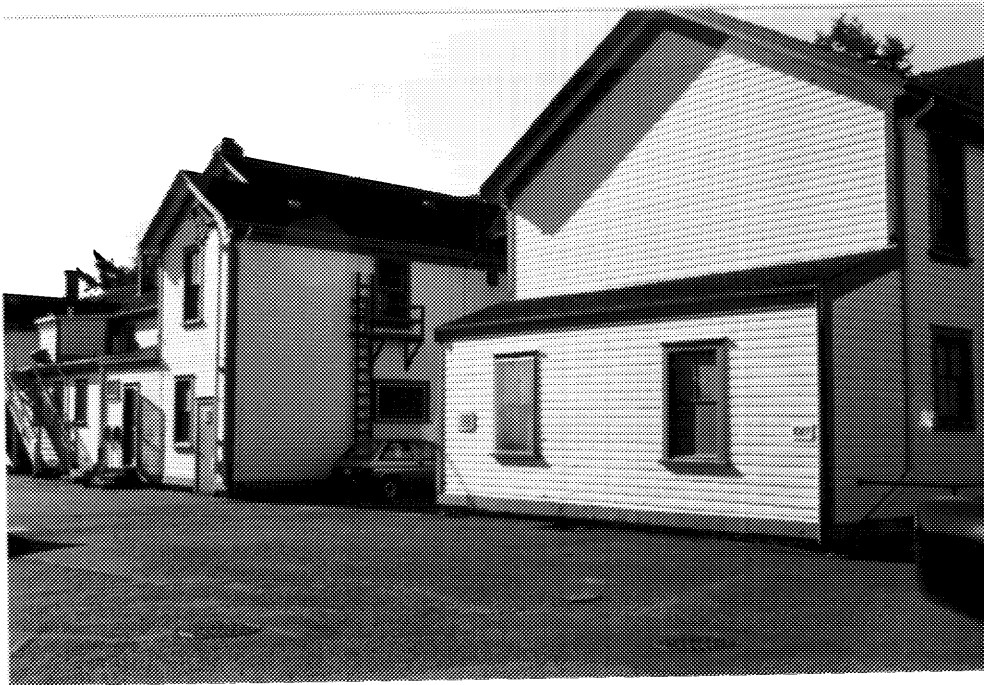
23 Officers' mess rear (north) elevation. (Ian Doull, AHB, Parks, 1989.)

A number of alterations have been performed to the ground floor exterior in the course of adapting the building to its new principal use as an officers' mess. At the rear the central kitchen annexes have been joined together by new construction (Figures 6 and 7). More changes have been made to the principal elevation. The original single-sash windows have all been replaced, in most cases with wider three-part units, each consisting of a fixed central pane with sash side lights (Figures 4, 5, 8, 9). Two bay windows project from the façade near the building's western end (Figure 10). One gabled porch situated near the mid-point of the elevation, and the doors it once sheltered have been removed (Figure 8). The easternmost porch, at the entrance to the former commanding officer's residence, now boasts a sun porch addition (Figure 11). These changes have only slightly reduced the level of symmetry expressed in the original design, and have been executed using compatible materials. The new elements exhibit the same scale, detail, and methods of craftsmanship as those of the original construction, and in consequence have not compromised the aesthetic integrity of the building.
