Naden, Museum Square, Building No. 35

Recognized Federal Heritage Building

Esquimalt, British Columbia

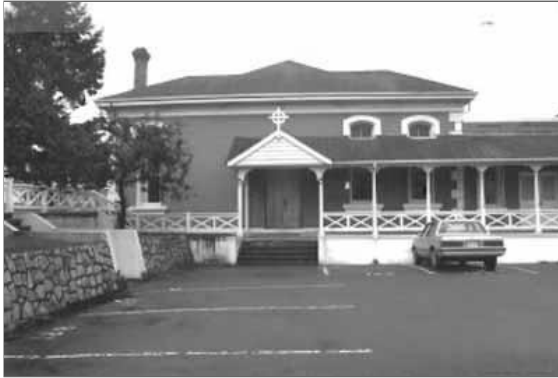
Front View

Buildings 35, 37 (the original administrative block), and 39 were erected as freestanding structures united along their courtyard elevation by a continuous balcony. This has since been converted to a covered verandah. Building No. 35 is a one-storey structure in brick. The hipped roof and the verandah, as well as the raised foundation, the bracketed cornice, and the segmentally-arched door and window openings with stone surrounds, give the building an architectural vocabulary consistent with the other original buildings in the compound.

Building 35 is I-shaped in plan, with small projecting side wings at the front and back, an arrangement typical for pavilion hospitals of the period. On the façade facing the harbour, opposite the courtyard, the massing is more pronounced, allowing an intermediate porch between the wings, and there is fairly rich Italianate detailing. This harbour façade, repeated symmetrically on the North Ward, welcomed those approaching the hospital complex from the shore.
